TEST REPORT

1. NO : CT21-097709E
2. Client
 - Name : COMFILE TECHNOLOGY Inc
 - Address : Comfile Building, 11-9, Gamasan-ro 27-gil, Guro-gu, Seoul, Korea
3. Date of Test : 2021.09.07 ~ 2021.09.29
4. Use of Report : Quality control
5. Test Sample : CWR-070WR
6. Test Method
 - (1) IEC 60529 Ed. 2.2 b:2013

7. Test Results

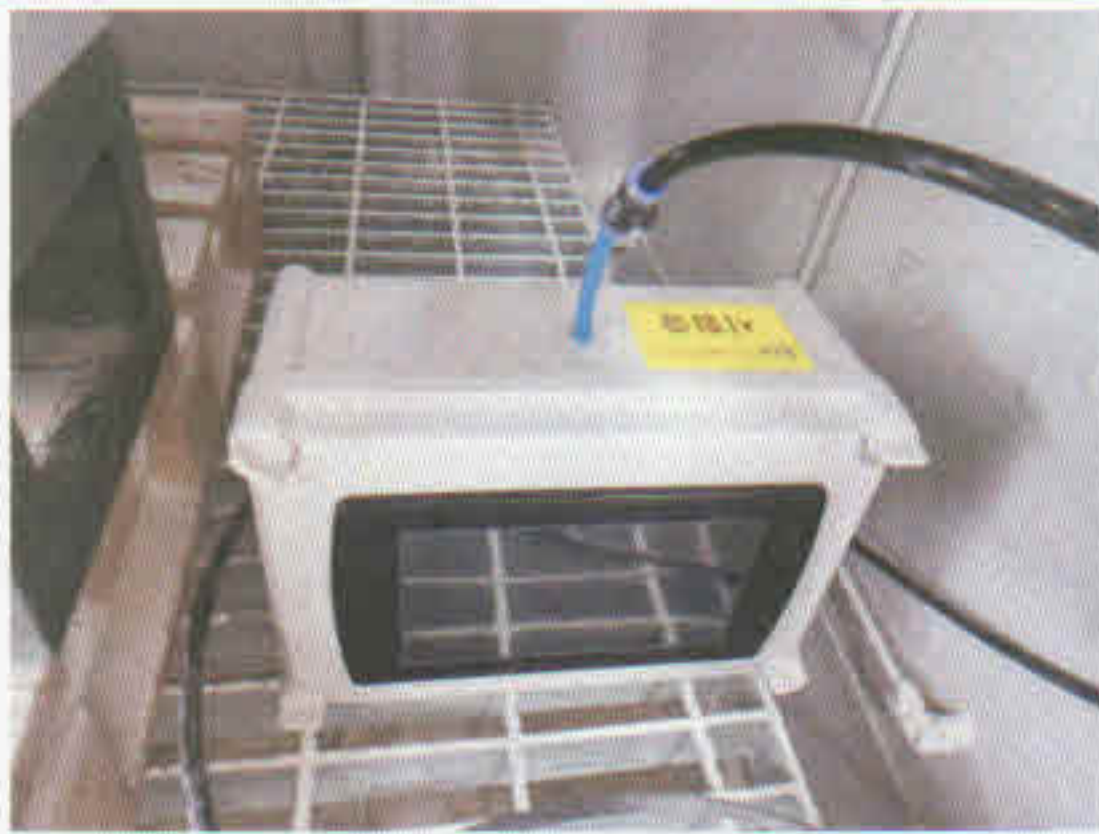
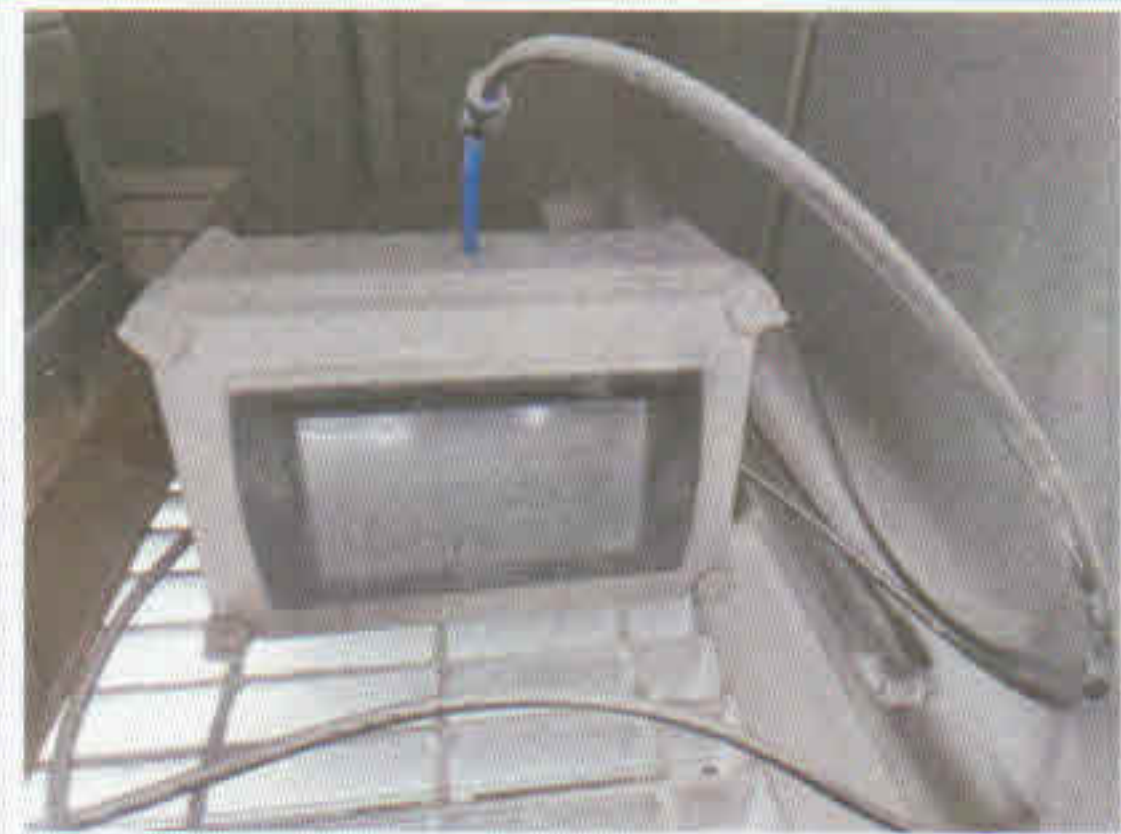
IP6X_Against ingress of solid foreign objects test

Before

After

▶ IP6X Test Method :

- Degrees of protection against access to hazardous parts :

The access probe is pushed against or inserted through any openings of the enclosure with the force Specified in table 6(1N ± 10 %).

- Degrees of protection against solid foreign objects :

Depressurize through the hose lower than 2 kPa and progress to test 8 h in the dust chamber.

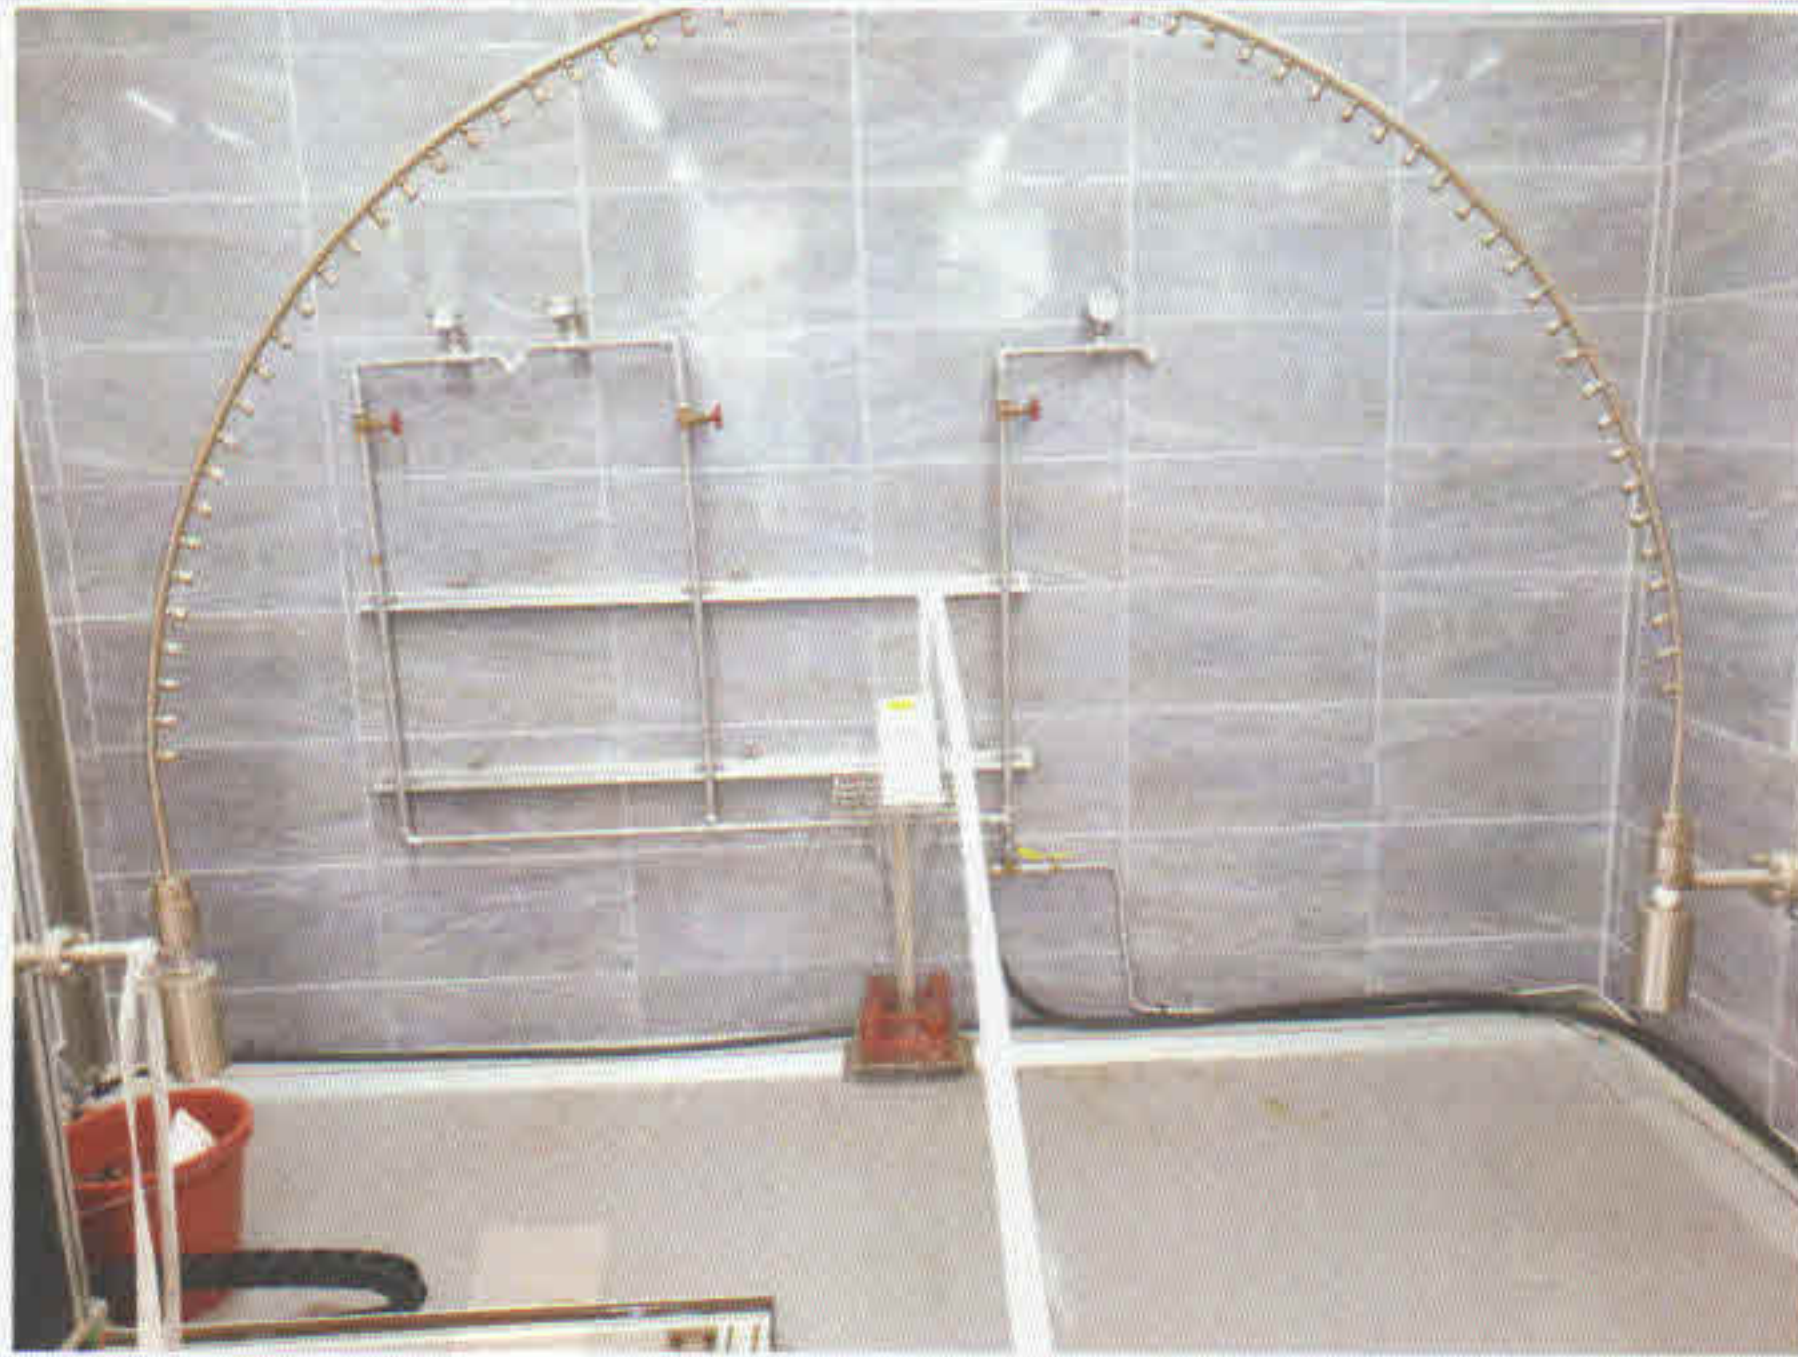
IPX5_Against ingress of water with harmful effects test

▶ IPX5 Test Method :

- Internal diameter of the nozzle : 6.3 mm

- Delivery rate : 12.5 L/min ± 5 %

- Distance from nozzle to enclosure surface : between 2.5 m and 3.0 m

- Test duration per square metre of enclosure surface area likely to be sprayed : 1 minute

- The duration of the test is 3 minutes.

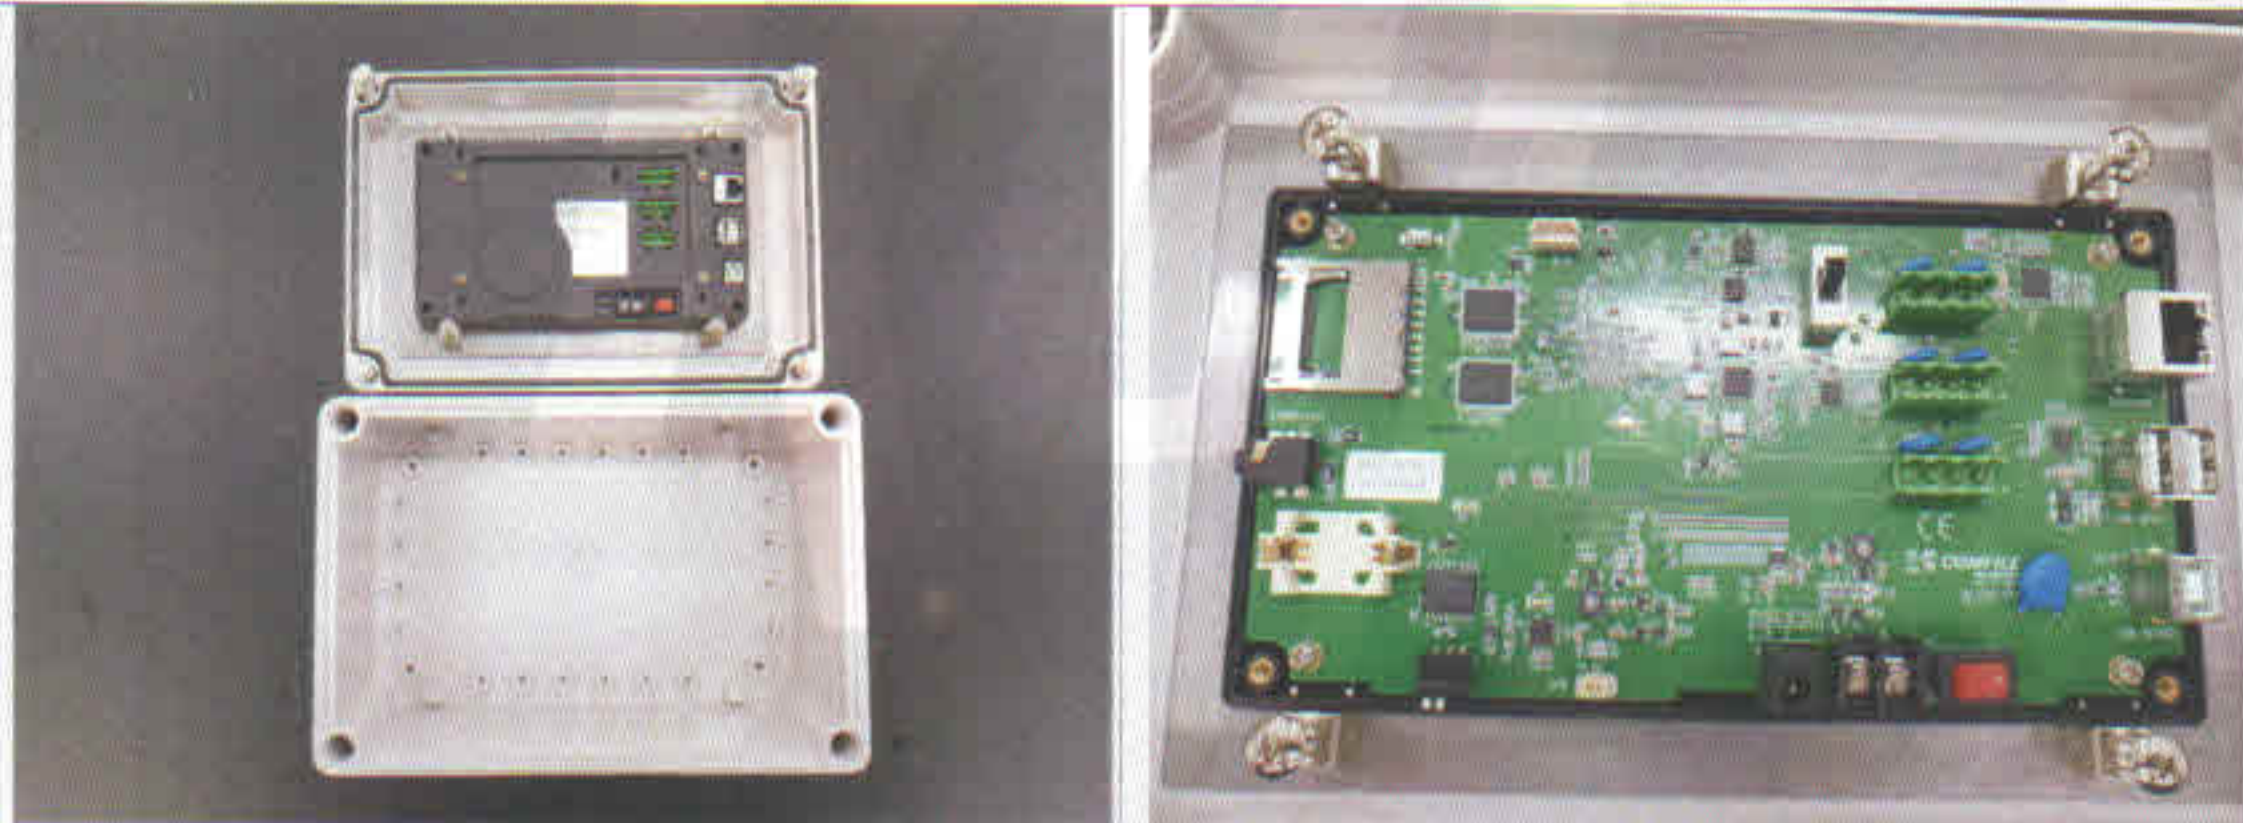
After IPX5_Against ingress of water with harmful effects test

Test Items	Unit	Test method	Test Results	Remark	Location
IP6X (Degrees of protection against access to hazardous parts and against solid foreign objects)	-	(1) IEC 60529 Ed. 2.2 b:2013	The full diameter of the object probe not pass through an opening of the enclosure. Adequate clearance have kept between the access probe and the hazardous area. No deposit of dust inside the enclosure	(23.0 ± 2.0) °C, (62 ± 3) % R.H.	A
IPX5 (Degrees of protection against ingress of water)	-	(1) IEC 60529 Ed. 2.2 b:2013	No ingress of water inside the enclosure	(22.0 ± 2.0) °C, (62 ± 2) % R.H.
